INSPECTION OF LAND

277 SOUTH PLAINFIELD AVE

MINFORD AVENUE

INSPECTION IS TO DETERMINE
IF THIS VACANT LAND IS OR IS
NOT A WETLAND AS DEFINED
BY : The 1989 Federal Manual for
Identifying and Delineating
Jurisdictional Wetlands

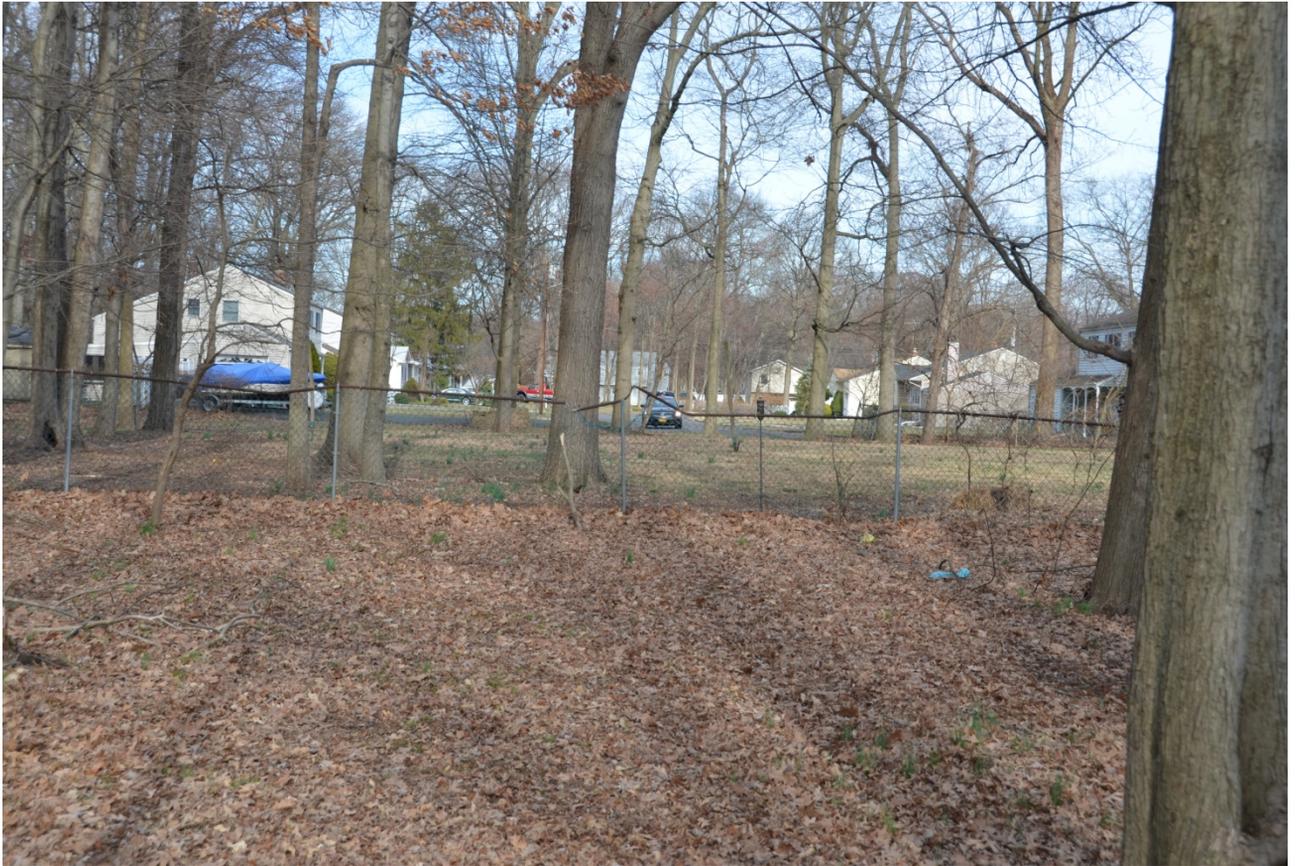
This photograph was taken during our inspection, the auto in the center of the photo with the lights on, is parked in the middle of Minford Avenue and the camera is pointed to the North East. It is obvious that Minford Avenue never existed in this section. The missing part of the street measures approximately 350 feet

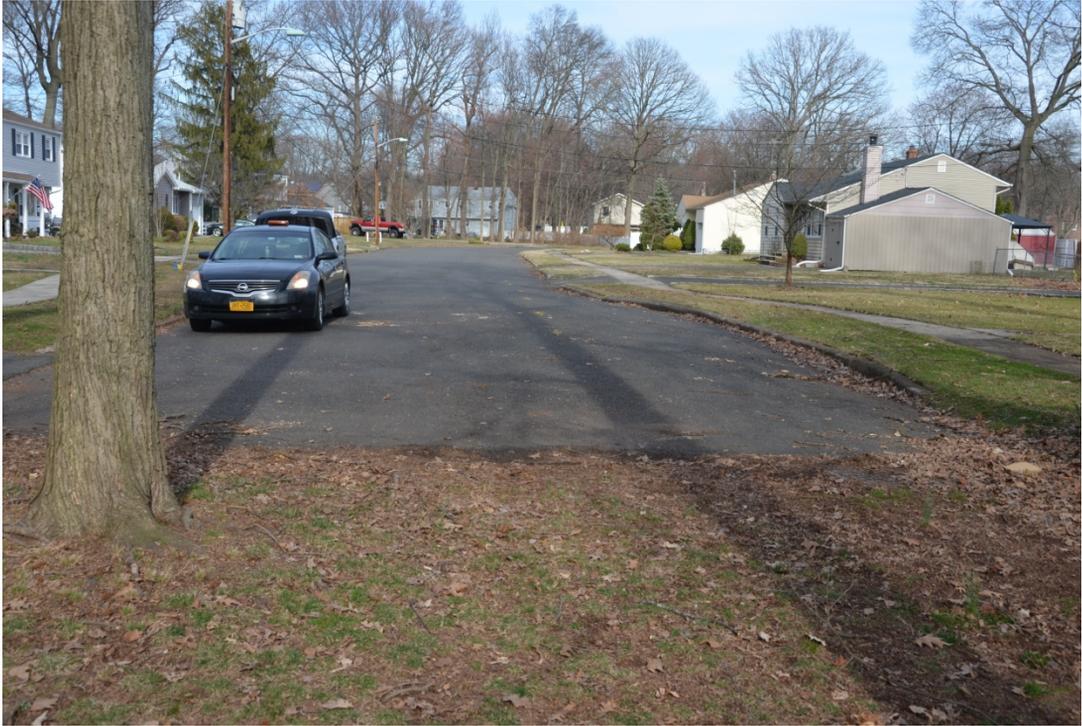
The termination point of the North East section of Minford Avenue.

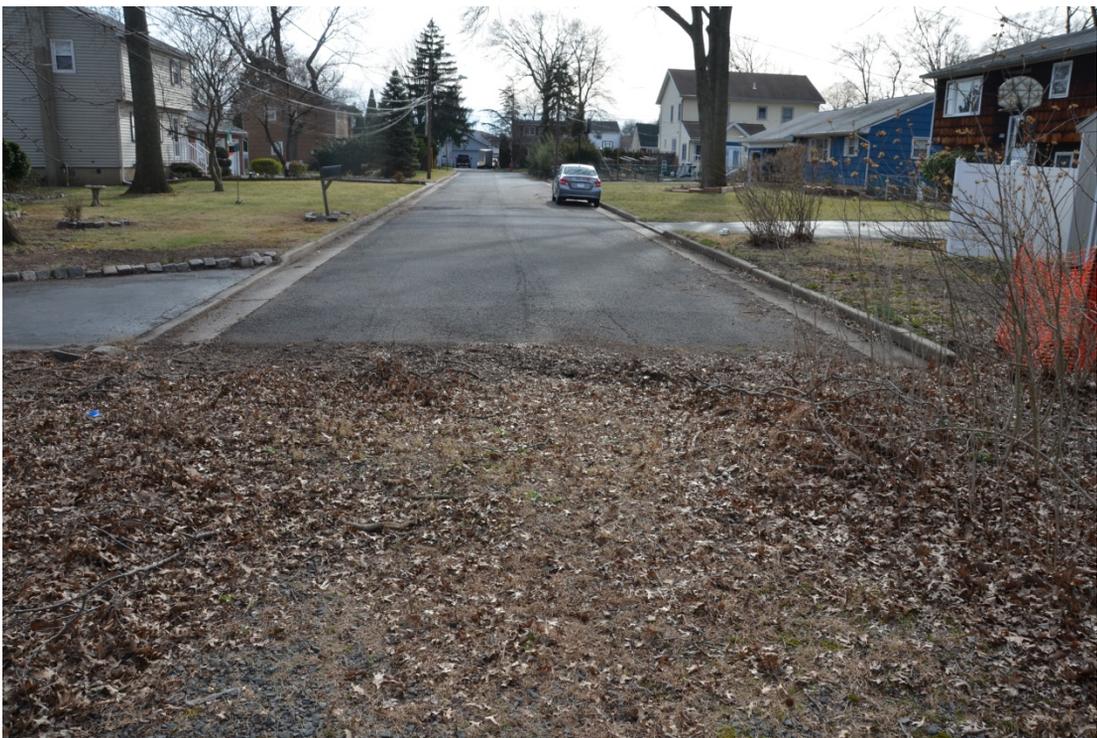
The termination point of the South West section of Minford Avenue.
